**[Docket No. FAA-2012-0182; Directorate Identifier 2012-CE-005-AD; Amendment 39-16958; AD 2012-03-52]**

#### **Airworthiness Directives; Mooney Aviation Company, Inc. (Mooney) Airplanes**

**ACTION:** Final rule; request for comments.

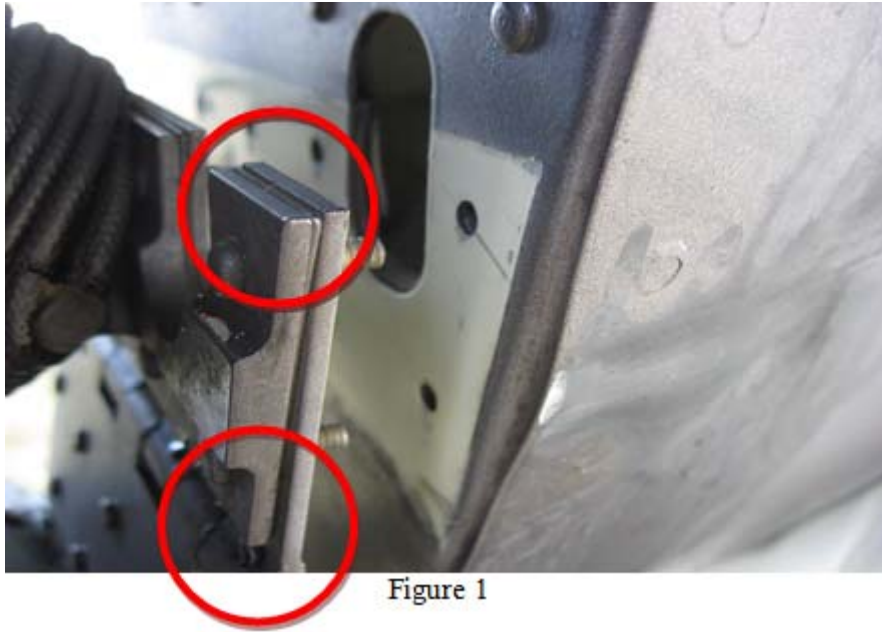
Figure 1

This aircraft was immediately inspected, and all 10 swaged collars that hold the tail trim assembly together had become unattached.

Mooney inspected several other aircraft and found that on one airplane the filler plate was incorrectly installed. The filler plate was not correctly installed between the aft side of the hinge and the bulkhead. Instead, the filler plate was located on the forward side of the hinge between the hinge and trim fitting. It was then noted the incident aircraft had the same issue, as shown in the upper circle of figure 1.

Because the hinge has a lip on the bottom, on the side toward the bulkhead (as shown in the bottom circle of figure 1), if the filler plate is not installed correctly, the hinge will not fit flush against the bulkhead, the Huck Bolt fasteners will not fit perpendicular to the bulkhead, and the

collars will not swage properly. The condition also causes excessive tension pre-load on the Huck Bolts.

The incident aircraft was manufactured in 2008. Mooney has determined the incorrect installation was a manufacturing quality escape during production.

This AD requires inspecting the trim fitting, hinge, and filler plate of the tail pitch trim assembly for correct positioning and proper attachment, and inspecting the Huck Bolt fasteners for proper security. If incorrect positioning or improper/loose attachment is found, the owner/operator must contact Mooney for FAA-approved repair instructions. The AD also requires sending the inspection results to the FAA and Mooney.

If during the inspection required in paragraph (g) of this AD you find incorrect positioning or improper attachment of the trim fitting, hinge, and filler plate of the tail pitch trim assembly; and/or you find loose or improperly installed Huck Bolt fasteners, before further flight, contact Mooney for FAA-approved repair instructions and perform the repair. Use the contact information found in paragraph (n)(2) of this AD.
