**[Docket No. 2002-SW-42-AD; Amendment 39-12936; AD 2002-17-51]**

### **Airworthiness Directives; Agusta S.p.A. Model A109E Helicopters**

**2002-17-51 Augusta S.p.A.:** Amendment 39-12936. Docket No. 2002-SW-42-AD. Supersedes Emergency AD 2002-14-51, Docket No. 2002-SW-35-AD.

**Applicability:** Model A109E helicopters, with tail rotor blade, part number 109-8132-01-111, installed, certificated in any category.

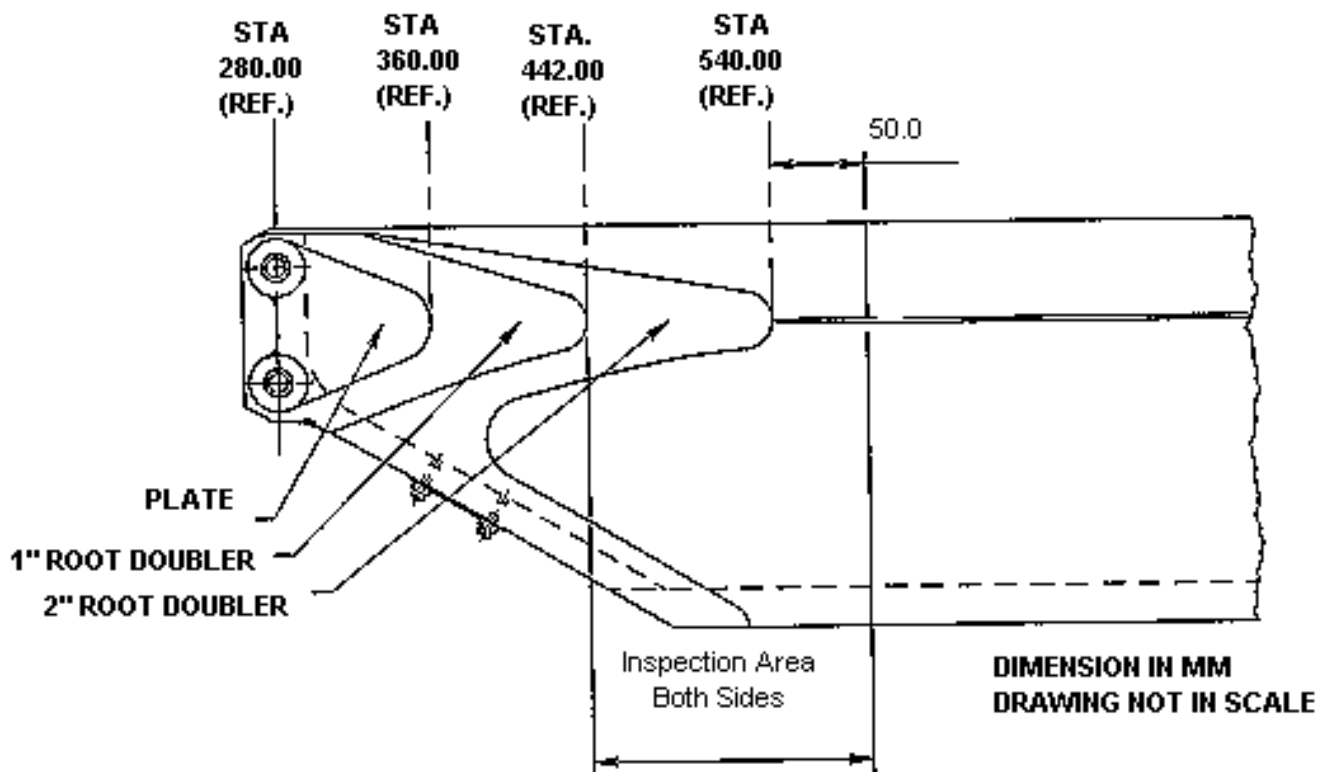
**FIGURE 1**

(b) Before each start of the helicopter engines, visually check both sides of each tail rotor blade for a crack in the area depicted in Figure 1 of this AD. And owner/operator (pilot) holding at least a private pilot certificate may perform this visual check and must enter compliance with this paragraph into the aircraft maintenance records in accordance with 14 CFR 43.11 and 91.417(d)(2)(v). See Figure 1:

**Part Number 109-8132-01-111 Tail Rotor Blade**

**Note 2:** Paint irregularities on the tail rotor blade may be due to a crack.

(d) Replace any cracked tail rotor blade with an airworthy blade before further flight.
