[Docket No. 75-CE-11-AD; Amdt. 39-2190]

**PART 39—AIRWORTHINESS DIRECTIVES**

**Beech Model 18 Airplanes**

AD 75-09-18 Published as Amendment 39-2190 to 14 CFR, Part 39

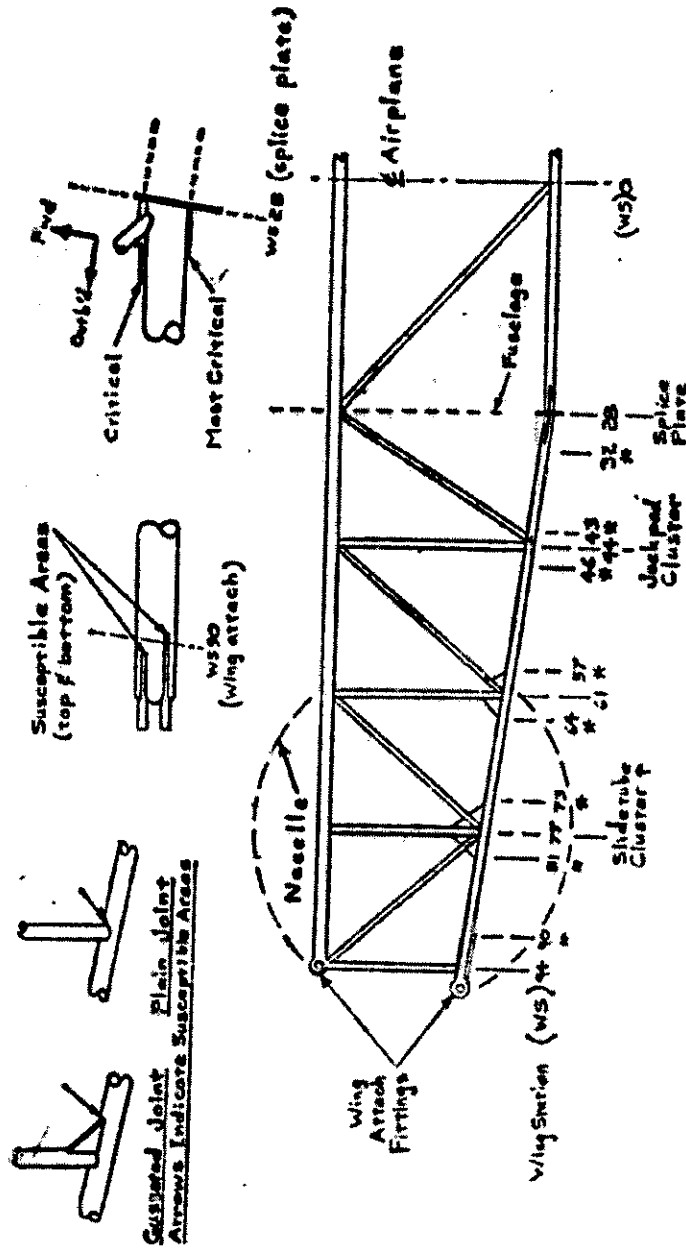
**FIGURE 3**

To prevent possible wing failure, in order to detect cracks in the elliptical front spar lower cap of the wing center section, outer wing panel and upper spar cap at station 90:

\* INDICATES AREAS TO BE INSPECTED PER THIS A.D.  
 † SEE AD 54-21-1, part (b) and AD 64-21-3, part (b).

B. (1) Inspect the front spar lower cap of the wing center section and outer wing panel on each side of the airplane by methods specified below, including inspection sites reinforced by Beech Aircraft Corporation Kits 18-4024, 791 or 792:

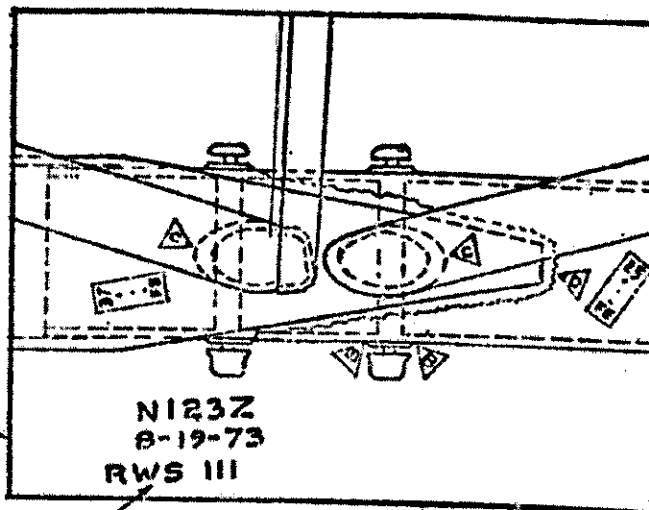
**FIGURE 6****EXAMPLE of  
X-RAY FILM at  
WS 111**

Double Film to  
Accomodate 0.166"  
Thickness  
Spar Cap Material.  
KODAK AA or M or  
Equivalent.

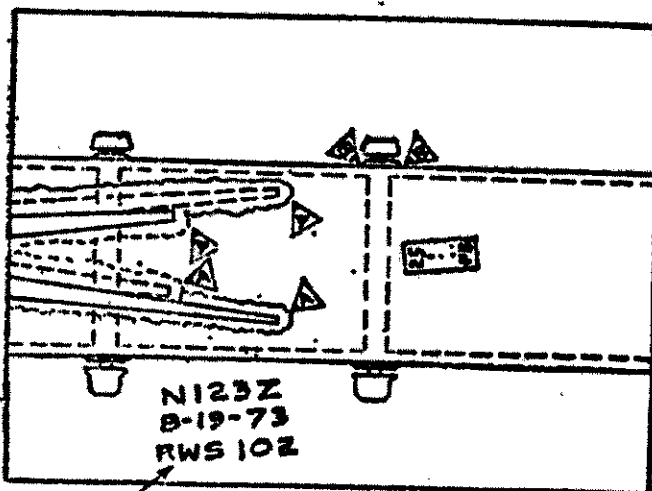
**EXAMPLE of  
X-RAY FILM at  
WS 102**

Single Film for  
0.19" Thickness  
Spar Cap Material.  
KODAK AA or M  
or Equivalent.
