# EMERGENCY AIRWORTHINESS DIRECTIVE

**AD #: 2002-23-51**

**2002-23-51 BELL HELICOPTER TEXTRON CANADA: Docket No. 2002-SW-51-AD.**

Applicability: Model 407 helicopters, serial numbers 53000 through 53538, certificated in any category.

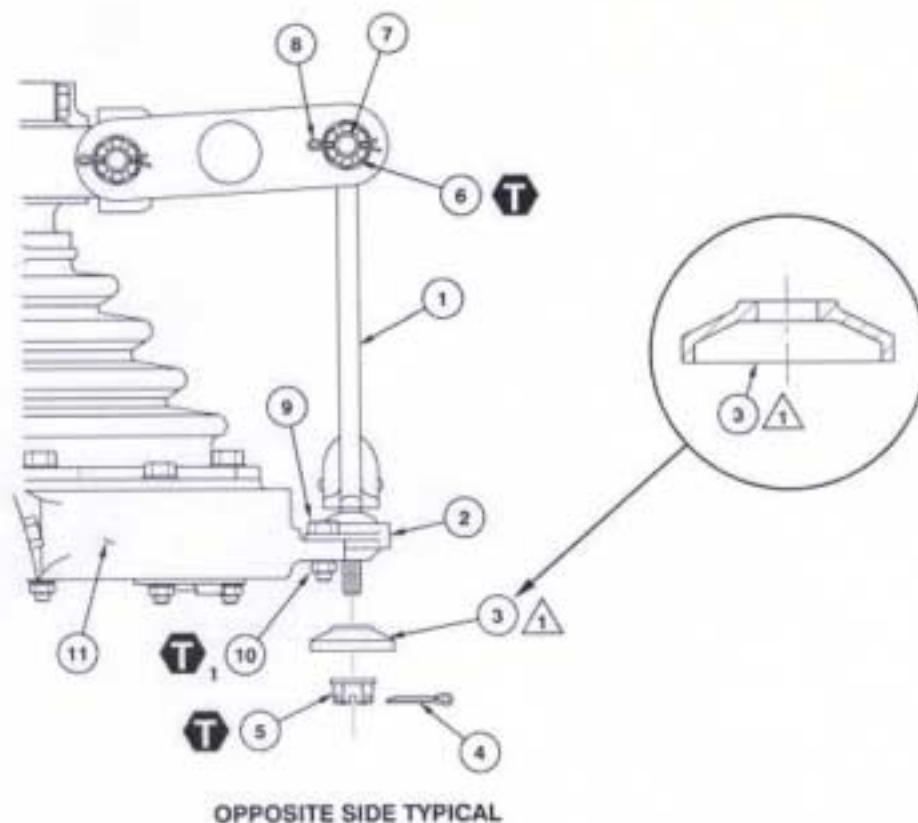
Figure 1. Correct cup washer direction, installation of

To detect an incorrect installation of swashplate drive link cup washers (cup washer), which could limit the travel of the swashplate outer ring and lead to stud failure, failure of both swashplate drive link studs, and loss of control of the helicopter, accomplish the following:

(a) Visually check both cup washers, part number (P/N) 406-010-412-101, for correct installation in accordance with Figure 1 of this AD as follows:

- 1** Washer shown is correctly installed.
2. Washers under bolt head (9) and nut (10) are not shown for clarity.

(1) If both cup washers are correctly installed, no further action is required.

(2) If one or both cup washers are installed incorrectly, remove and replace the swashplate outer ring, each cup washer that was installed incorrectly, and the bearing, liner, and drive link where the cup washer was installed incorrectly. Accomplish the replacements in accordance with Part II of the Accomplishment Instructions in Bell Helicopter Textron Alert Service Bulletin No. 407-02-55, dated October 29, 2002.
