## **EMERGENCY** **AIRWORTHINESS DIRECTIVE**

**AD #:** 2012-21-51

2012-21-51 **EUROCOPTER FRANCE:** Directorate Identifier 2012-SW-095-AD.

This EAD defines the unsafe condition as severe vibrations due to failure of bearings. This condition could result in failure of the tail rotor and subsequent loss of control of the helicopter.

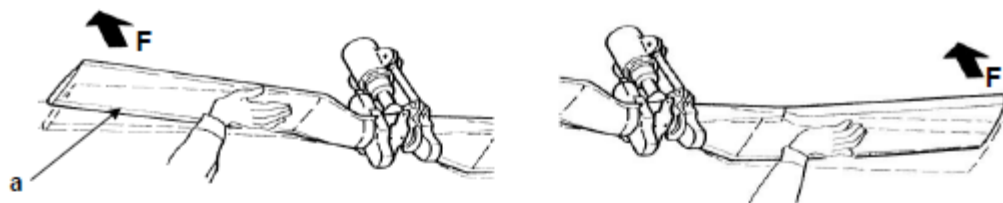
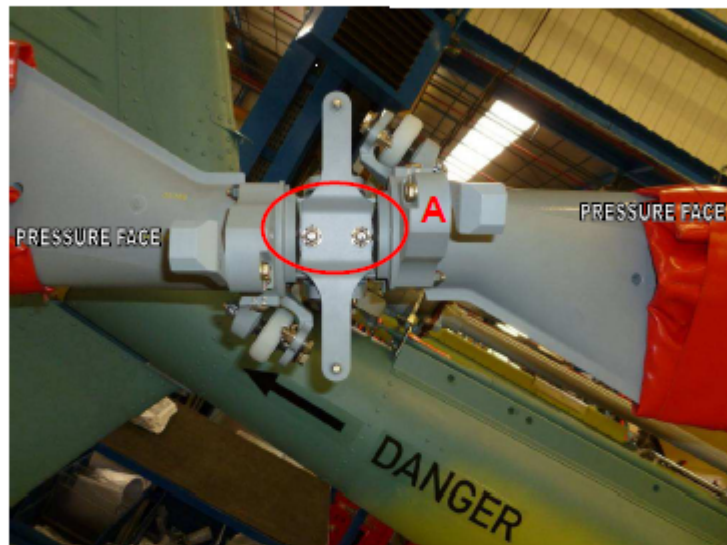
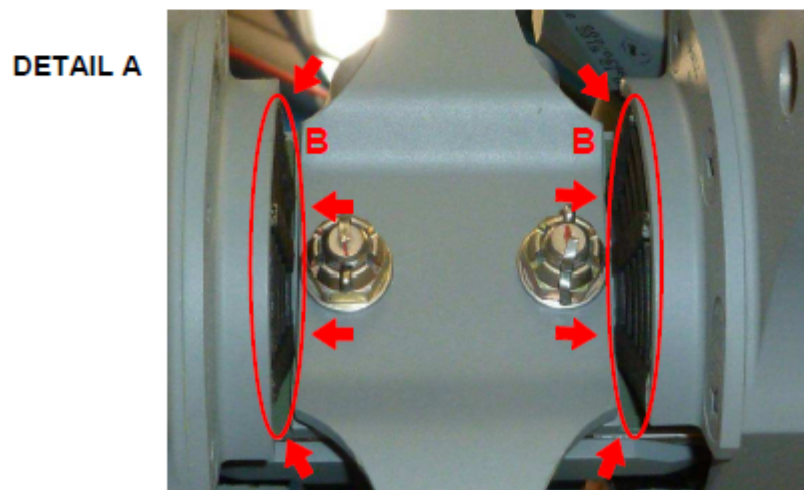
Figure 5 to paragraphs (e)(3)(ii) and (e)(3)(iii)

(iii) While maintaining the load, check all the visible faces of the bearings (front and side faces) in area B of DETAIL A of Figure 5 to paragraphs (e)(3)(i) and (e)(3)(iii) of this EAD for separation between the elastomer and metal parts, a crack in the elastomer, or an extrusion (see example in Figure 6 to paragraph (e)(3)(iii) of this EAD).

(5) If there is an extrusion on any bearing, before further flight, replace the four bearings with airworthy bearings.

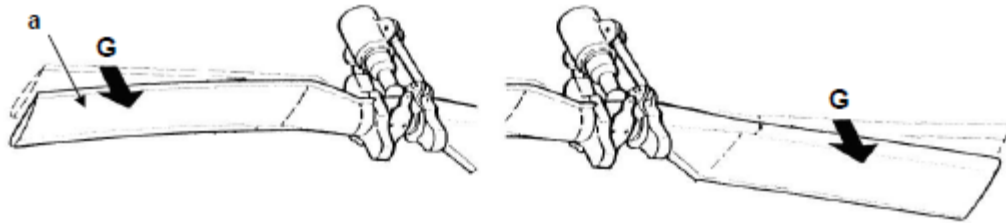
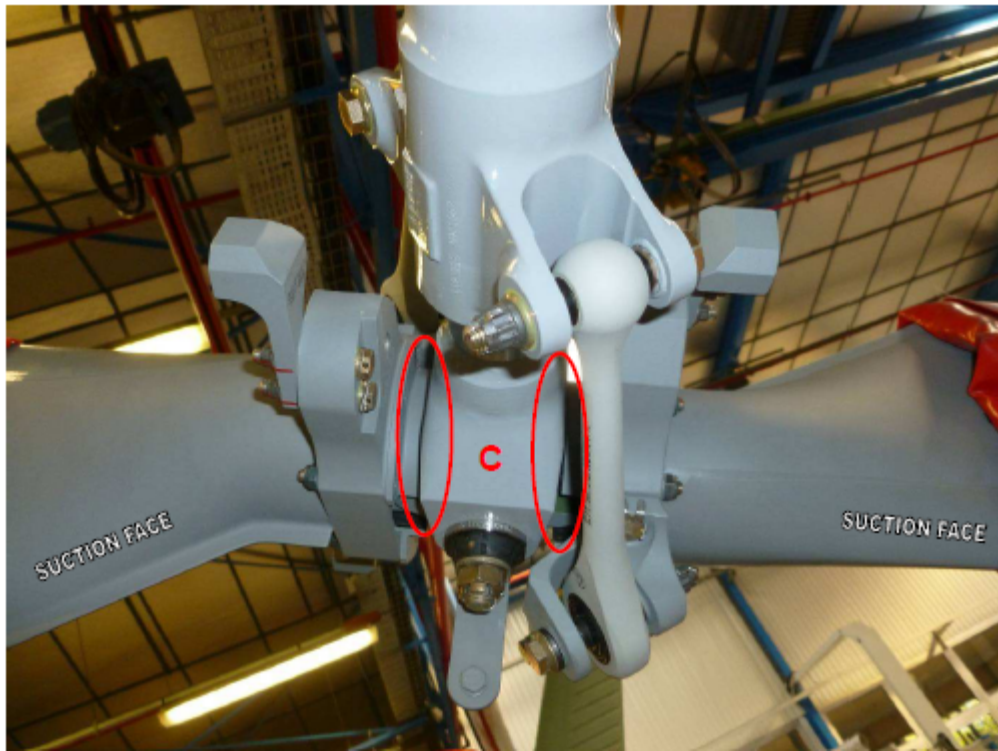
(vi) While maintaining the load, check visible faces of Area C as shown in Figure 7 to paragraphs (e)(3)(v) and (e)(3)(vi) of this EAD for any extrusion.

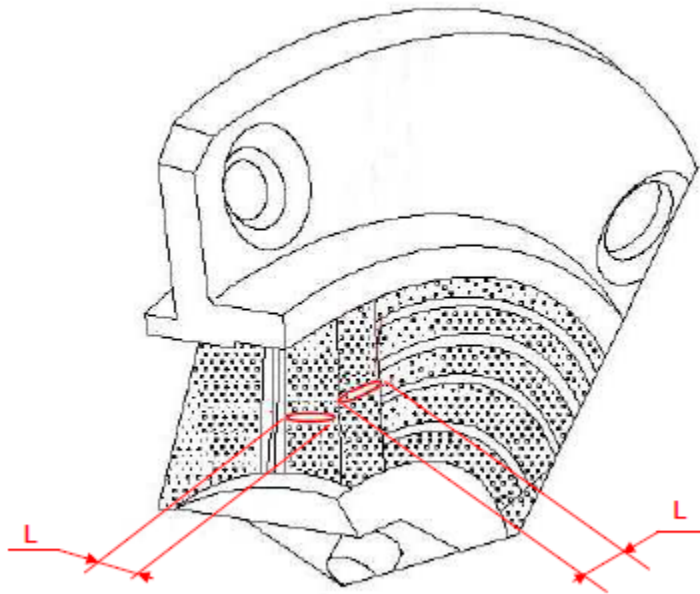
Figure 8 to paragraph (e)(6)

(6) If there is a separation or a crack on the pressure side bearing, measure the separation or the crack. If the separation or crack is greater than 5 millimeters (.196 inches) as indicated by dimension "L" in Figure 8 to paragraph (e)(6), before further flight, replace the four bearings with airworthy bearings.
