**[Docket No. FAA-2018-0188; Product Identifier 2018-CE-002-AD; Amendment 39-19285; AD 2018-10-10]**

#### **Airworthiness Directives; Diamond Aircraft Industries GmbH Airplanes**

**2018-10-10 Diamond Aircraft Industries GmbH:** Amendment 39-19285; Docket No. FAA-2018-0188; Directorate Identifier 2018-CE-002-AD.

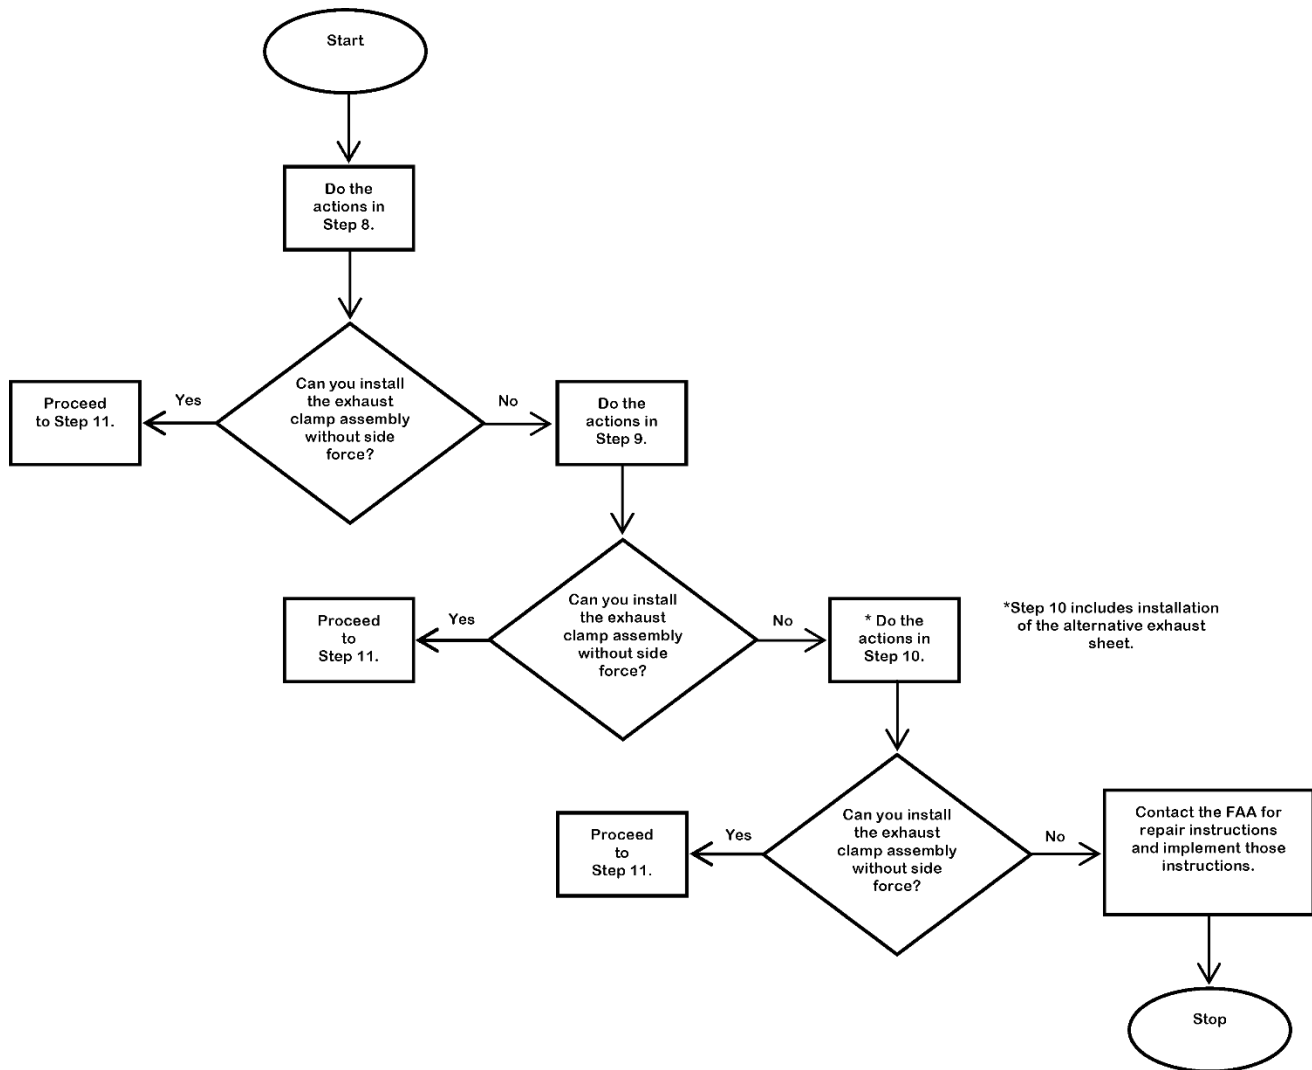
Figure 1 to paragraph (g)(3) of this AD:  
Sequence of Actions for Exhaust Clamp Installation Identified in  
DAI Work Instruction WI-MSB 42-120, Revision 3, dated July 6, 2017, and  
Revision 4, dated December 20, 2017

(3) Before further flight after the initial inspection required in paragraph (g)(1) of this AD and if no cracks were found or a repair to the exhaust pipe heat shield was done as required in paragraph (g)(2)(i) of this AD, then install additional engine exhaust pipe clamps, DAI P/Ns D60-7806-00-01 and D60-7806-00-02, and exhaust sheet, P/N D60-7806-00-03, and incorporate spring washers. Do the installations following III.2 Action 2—installation of additional exhaust clamp in the

INSTRUCTIONS section of DAI Work Instruction WI-MSB 42-120, Revision 3, dated July 6, 2017, or Revision 4, dated December 20, 2017. See figure 1 to paragraph (g)(3) of this AD for additional information on the sequence of installation actions as identified in DAI Work Instruction WI-MSB 42-120, Revision 3, dated July 6, 2017 and Revision 4, dated December 20, 2017.

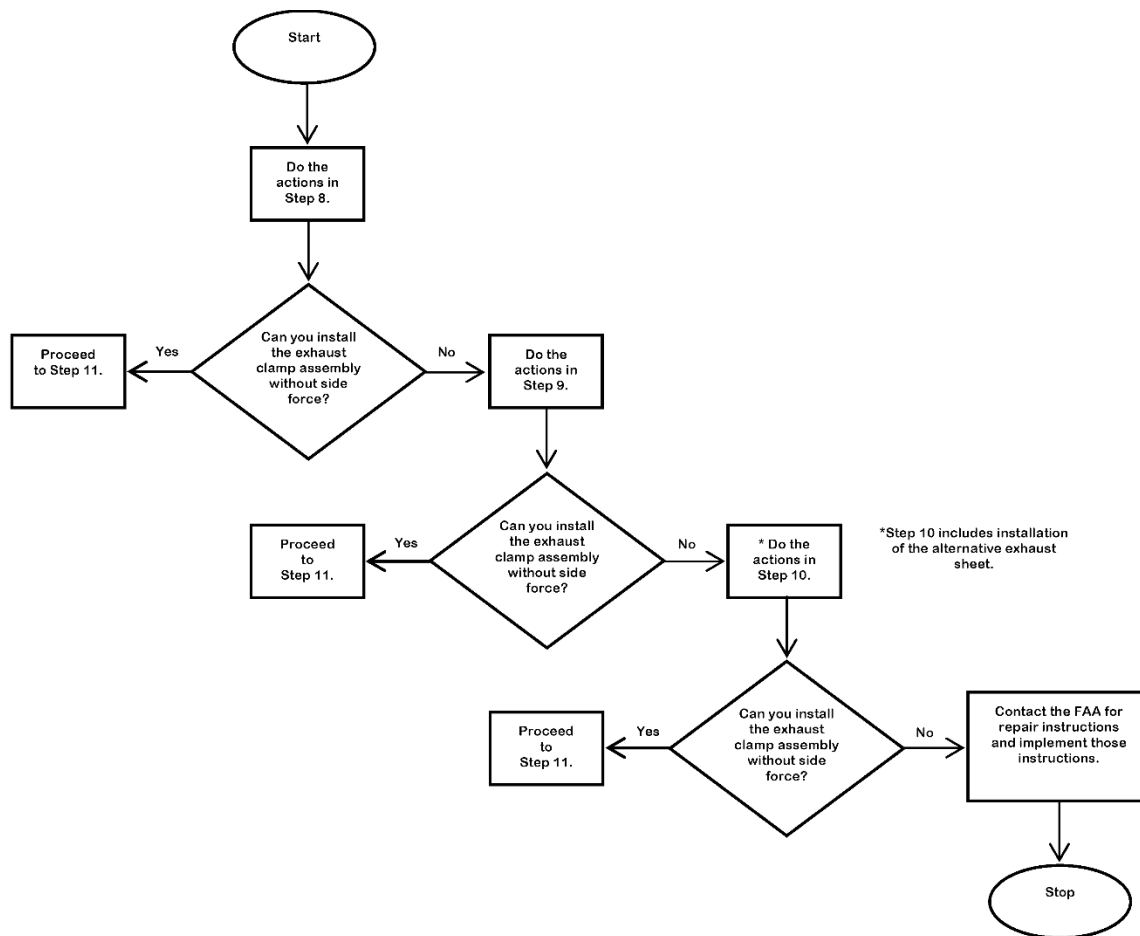
Figure 2 to paragraph (h)(7) of this AD:  
Sequence of Actions for Exhaust Clamp Installation Identified in  
DAI Work Instruction WI-MSB 42-120, Revision 3, dated July 6, 2017, and  
Revision 4, dated December 20, 2017

(7) Before further flight after any inspection required in paragraph (h)(6) of this AD and no crack is found, reinstall the engine exhaust pipe clamp and incorporate spring washers following III.2 Action 2–installation of additional exhaust clamp in the INSTRUCTIONS section of DAI Work Instruction WI-MSB 42-120, Revision 3, dated July 6, 2017, or Revision 4, dated December 20, 2017. See figure 2 to paragraph (g)(7) of this AD for additional information on the sequence of installation actions as identified in DAI Work Instruction WI-MSB 42-120, Revision 3, dated July 6, 2017, and or Revision 4, dated December 20, 2017. Continue with the 25-hour TIS repetitive inspection as long as no cracks are found.
