**[Docket No. 2002-SW-25-AD; Amendment 39-13217; AD 2003-13-15]**

### **Airworthiness Directives; Schweizer Aircraft Corporation Model 269A, 269A-1, 269B, 269C, and TH-55A Helicopters**

**2003-13-15 Schweizer Aircraft Corporation:** Amendment 39-13217. Docket No. 2002-SW-25-AD. Supersedes AD 2001-25-52, Amendment 39-12726, Docket No. 2001-SW-58-AD.

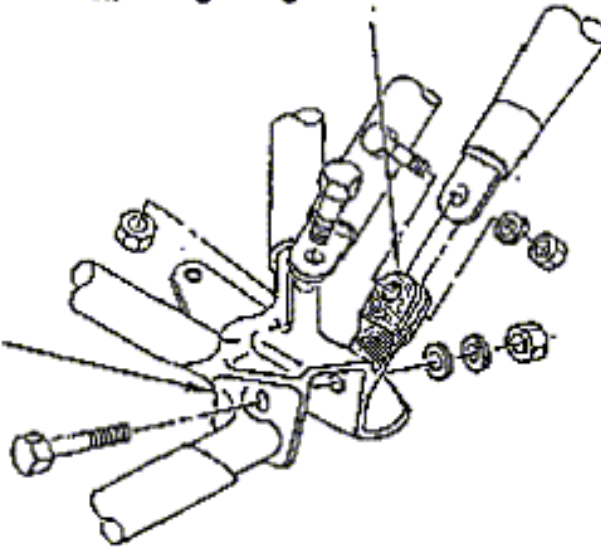
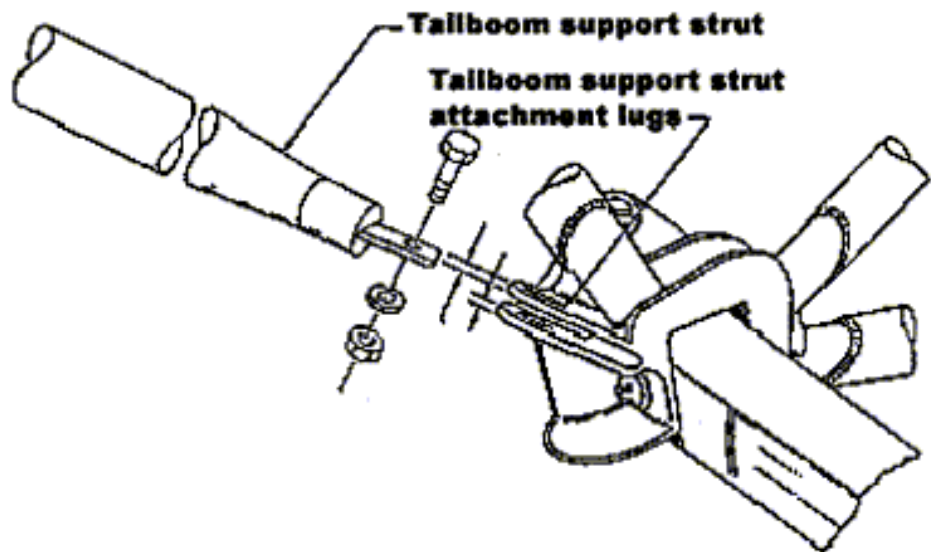
(2) Dye-penetrant inspect the lugs on each cluster fitting. See the following Figure 1:

**Inspect both attachment  
lugs (top and bottom sides).  
Also, entire cluster fitting  
including flange area.**

**269A2234  
Aft cluster fitting  
Left side shown  
(269A2235 right side)**

**Right side cluster fitting shown**

(3) If a crack is found, before further flight, replace the cracked cluster fitting with an airworthy cluster fitting.
