### **Airworthiness Directives; Maule Aerospace Technology Corp. M-4, M-5, M-6, M-7, MX-7, and MXT-7 Series Airplanes and Models MT-7-235 and M-8-235 Airplanes; Correction**

### **Airworthiness Directives; Maule Aerospace Technology Corp. M-4, M-5, M-6, M-7, MX-7, and MXT-7 Series Airplanes and Models MT-7-235 and M-8-235 Airplanes**

**98-15-18 Maule Aerospace Technology Corp.:** Amendment 39-10669; Docket No. 98-CE-01-AD; Supersedes AD 95-26-18, Amendment 39-9476.

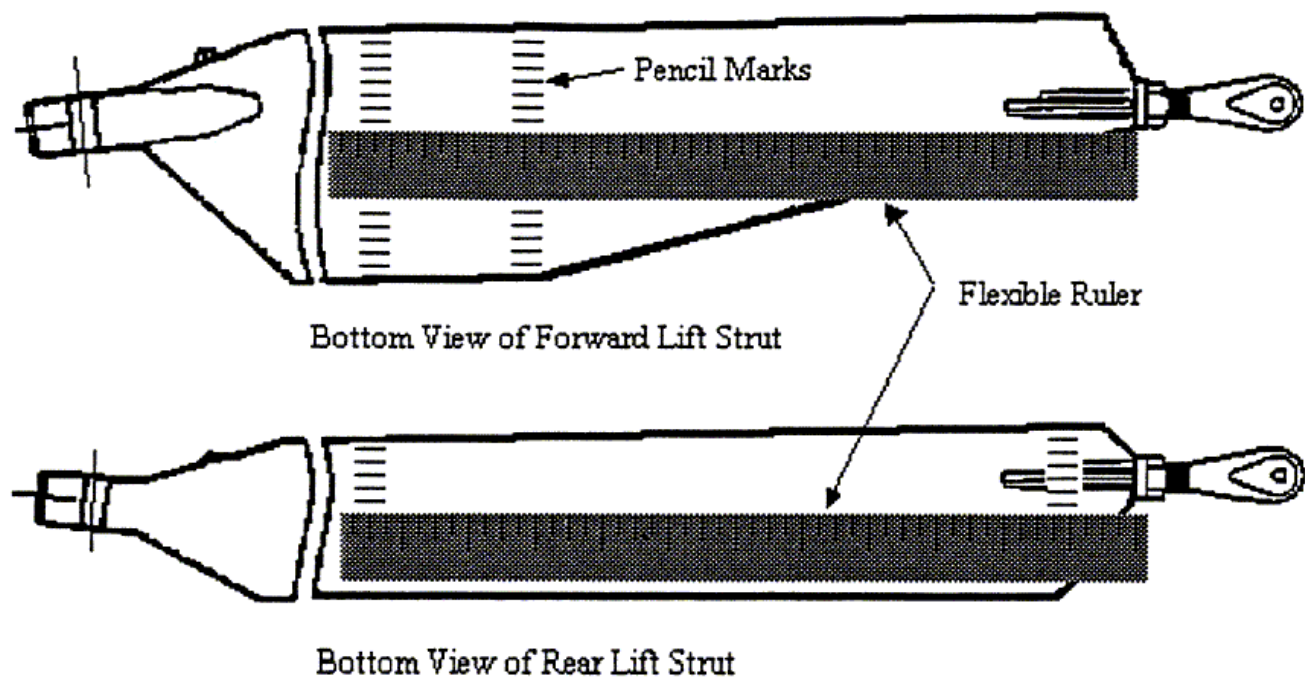
**Figure 1**

2. Using a flexible ruler, draw a 1/4-inch grid on the surface of the first 11 inches from the lower end of the strut as shown in Maule Service Bulletin No. 11, dated October 30, 1995. This can be done using a soft (#2) pencil and should be done on both faces of the strut. As an alternative to drawing a complete grid, make two rows of marks spaced every 1/4 inch across the width of the strut. One row of marks should be about 11 inches from the lower end of the strut, and the second row should be several inches away where the strut starts to narrow. Lay the flexible ruler between respective tick marks of the two rows and use tape or a rubber band to keep the ruler in place. See Figure 1.
