**[Docket No. FAA-2008-0490; Directorate Identifier 2008-SW-26-AD; Amendment 39-15509; AD 2008-10-03]**

**Airworthiness Directives; Bell Helicopter Textron Model 204B, 205A, 205A-1, 205B, 210, 212, 412, 412CF, and 412EP Helicopters**

**ACTION:** Final rule; request for comments.

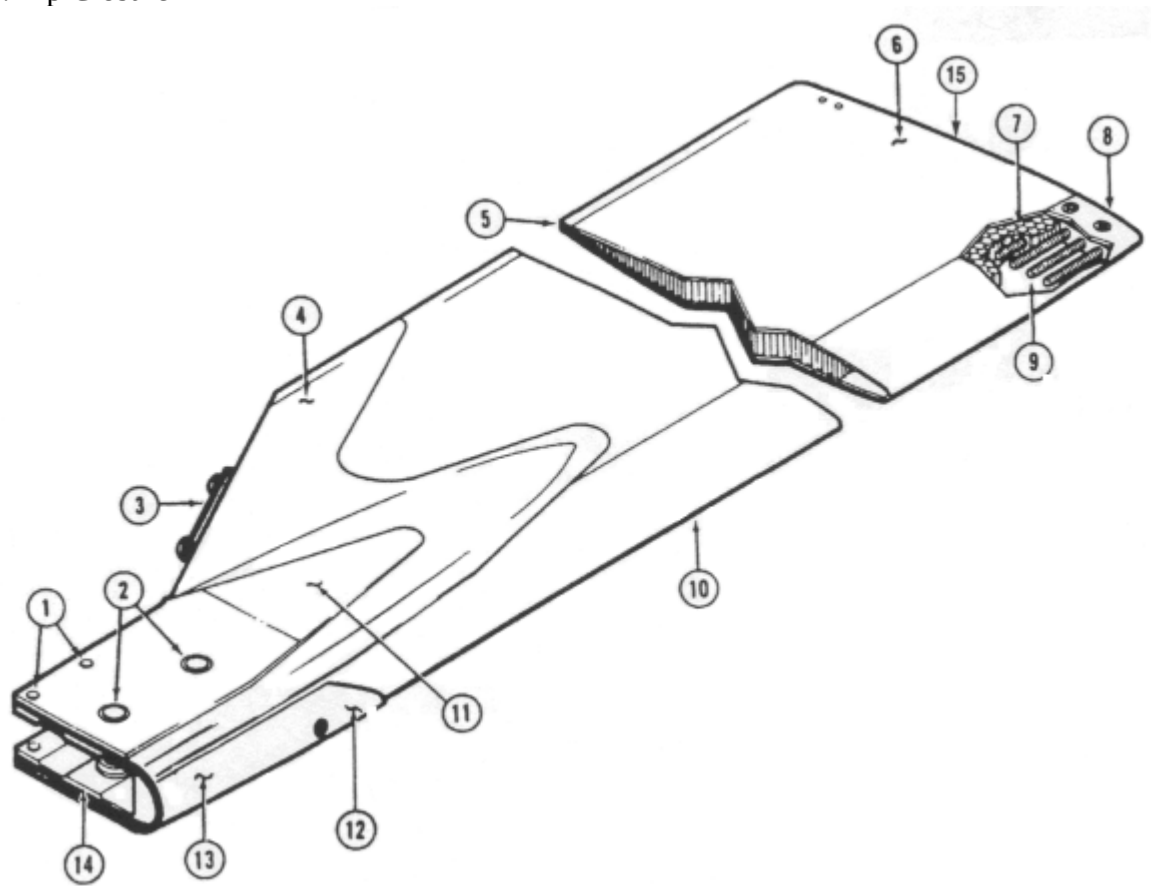
**T/R Blade Assembly**  
**Figure 1**

(2) Using a 3-power or higher magnifying glass and a bright light, visually inspect the T/R blade skins, leading edge spar, doublers, grip plates, and trailing edge for a crack, corrosion (may be indicated by blistering, peeling, flaking, bubbling, or cracked paint) and any other damage (including a nick, scratch, or dent). See Figure 1 of this AD. Pay particular attention to both sides of the T/R blade in the area located 16 to 26 inches from the T/R blade tip (blade station 25 to 35—the T/R blade tip is located at blade station 51) and to the inboard blade butt area near the attachment of the external balance weights and screws. Also pay particular attention to any blade surface that was snagged by the cloth, as that may be an indication of a crack or paint chip that could lead to corrosion.

(3) If any blistering, peeling, flaking, bubbling, or cracked paint is detected, remove the paint from the affected area and visually inspect the affected area for corrosion or a crack using a 10-power or higher magnifying glass. If any corrosion is found, measure the depth of the corrosion (a digital optical micrometer is one tool that can be used for this measurement).

(4) If a nick, scratch, or dent is found, visually inspect for a crack using a 10-power or higher magnifying glass and measure the depth of the damage (a digital optical micrometer is one tool that can be used for this measurement).

(1) Replace any T/R blade that has a crack with an airworthy blade.

(2) Replace any T/R blade that has any corrosion, nick, scratch, dent, or other damage that exceeds any maximum repair limit with an airworthy blade.

(3) Repair or replace with an airworthy blade any T/R blade that has any corrosion, nick, scratch, dent or other damage that is within the maximum repair limits.
