### **Federal Aviation Administration**

**[Docket No. FAA-2010-0342; Directorate Identifier 2002-NE-08-AD; Amendment 39-16458; AD 2010-20-23]**

### **Airworthiness Directives; Bombardier-Rotax GmbH Type 912 F, 912 S, and 914 F Series Reciprocating Engines**

**ACTION:** Final rule.

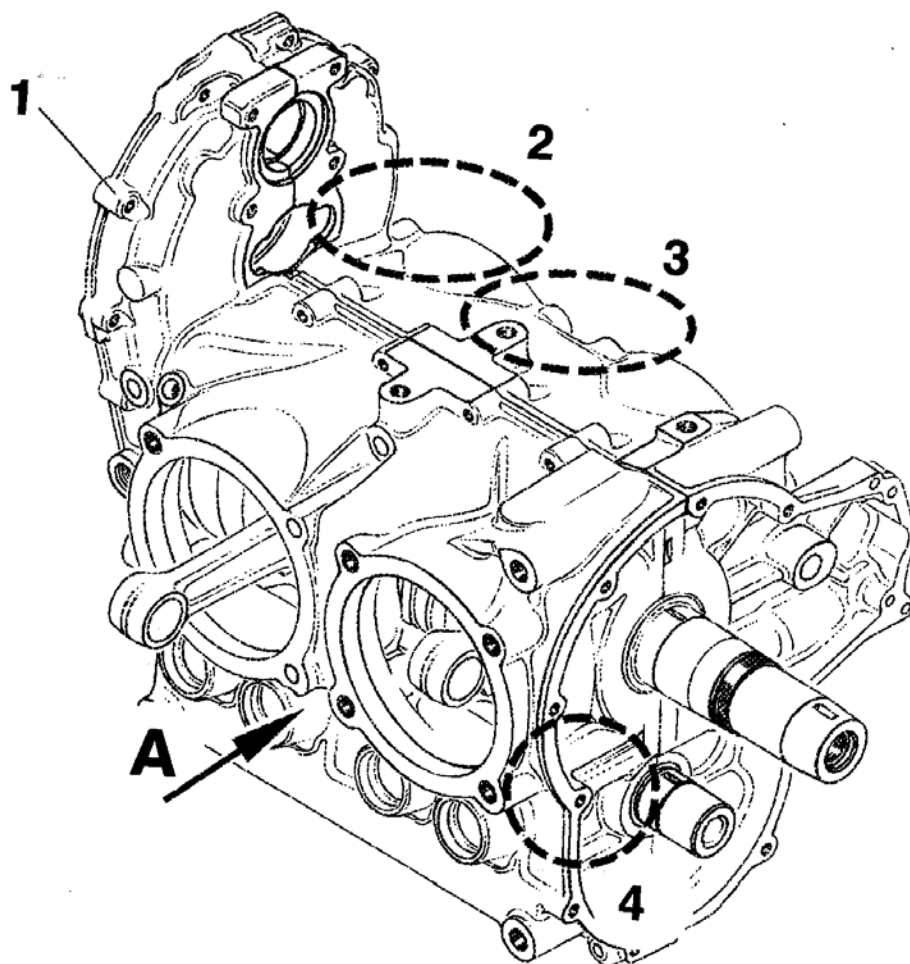
**Figure 1. Engine Crankcase Inspection Areas**

(d) This AD results from an increase in the affected engine crankcase population. We are issuing this AD to prevent oil loss caused by cracks in the engine crankcase, which could lead to in-flight failure of the engine and forced landing.

(1) Inspect the engine crankcase (item 1, Figure 1 of this AD) for cracks especially in the area of cylinder 1 upper side (item 2), between cylinder 1 and 3 upper side (item 3), cylinder 4 lower-right side (item 4) and detailed inspection in the area identified in Figure 2 (item 5) of this AD.

(2) Cracks in crankcases of engines with a ROTAX cooling air baffle may not be easily visible, and oil leaks may be an indication of cracks. Visually inspect for oil leaks in areas of cylinder 1 upper side (item 2, Figure 1 of this AD) and between cylinder 1 and cylinder 3 upper side (item 3).

(4) If the engine crankcase is cracked, remove the engine from service before further flight.

(h) Visually inspect the engine crankcase (item 1, Figure 1 of this AD) for cracks at each 100-hour, annual, or progressive inspection, or within 110 hours TIS since last inspection, whichever occurs first, in accordance with paragraphs (g)(1) through (g)(4) of this AD.

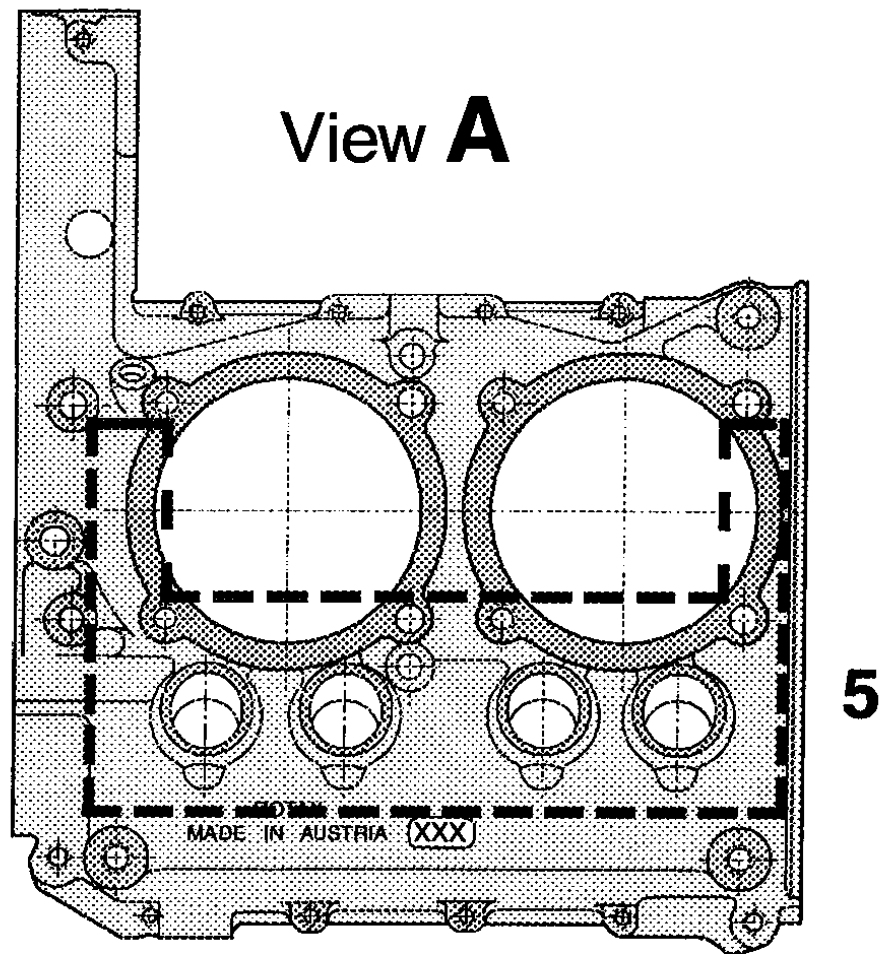
**Figure 2. Engine Crankcase Inspection Areas – View A**

(f) Determine if your crankcase is affected by looking at the S/N in the area indicated by XXX, following "Made in Austria," as shown on Figure 2 of this AD. The marking is on both crankcase halves.
