**[Docket No. 2004-SW-12-AD; Amendment 39-13884; AD 2004-24-08]**

### **Airworthiness Directives; Bell Helicopter Textron Canada Model 206A, B, L, L-1, L-3, and L-4 Helicopters**

**2004-24-08 Bell Helicopter Textron Canada: Amendment 39-13884. Docket No. 2004-SW-12-AD.**

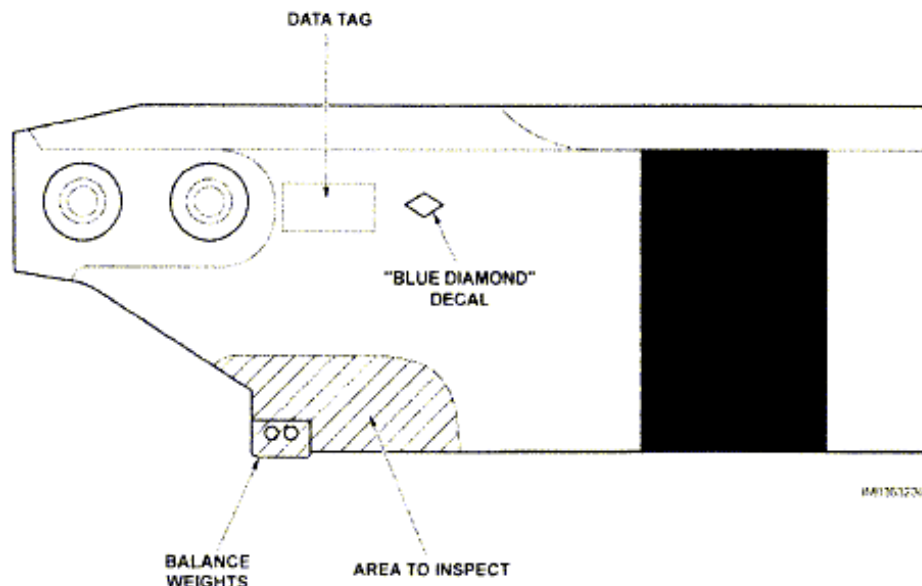
**Figure 1. Tail rotor blade inspection.**

(a) Before further flight, unless accomplished previously, and before installing any blade with a P/N and S/N listed in the applicability section of this AD, clean the blade. Using a 10X or higher magnifying glass, inspect both sides of each blade for a deformation, a crack, and a bent or deformed weight in the area shown in Figure 1 of this AD.

**Note 1:** Paint irregularities on the blade may indicate a crack.

(1) At intervals not to exceed 12 hours time-in-service (TIS), using a 10X or higher magnifying glass, inspect both sides of each blade for a deformation, a crack, and a bent or deformed weight in the area shown in Figure 1 of this AD, or

(2) Inspect and check both sides of each blade for a deformation, a crack, and a bent or deformed weight in the area shown in Figure 1 of this AD as follows:

(c) Before further flight, replace any blade that has a deformation, a crack, or a bent or deformed weight with an airworthy blade.
