**[Docket No. 2001-SW-40-AD; Amendment 39-12793; AD 2002-13-05]**

### **Airworthiness Directives; MD Helicopters, Inc. Model 369D, 369E, 369F, and 369FF Helicopters**

## **2002-13-05 MD Helicopters, Inc.:** Amendment 39-12793. Docket No. 2001-SW-40-AD.

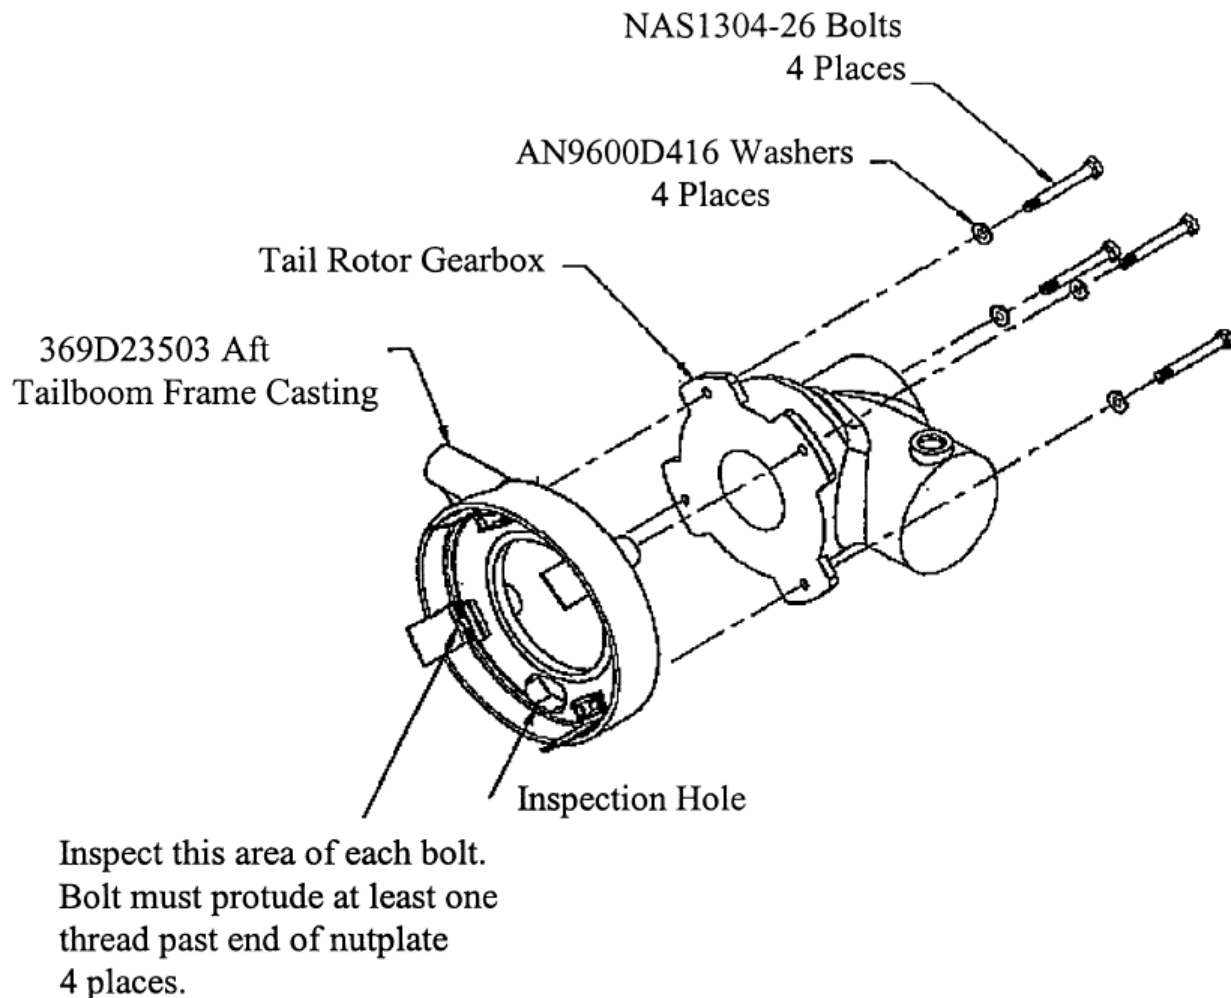
**Figure 1 - Inspection Location**

To prevent loss of the tail rotor gearbox due to attaching bolts of inadequate grip length and subsequent loss of helicopter control, accomplish the following:

- (a) Within 25 hours time-in-service (TIS), conduct the following inspections:
  - (1) For each tail rotor gearbox attaching bolt (bolt):
    - (i) Determine the part number (P/N).
    - (ii) If the P/N cannot be determined or if the bolt is not P/N NAS1304-26, before further flight, replace the bolt with bolt, P/N NAS1304-26.
    - (iii) Torque the bolt to 100-110 in-lbs and apply a slippage mark.
  - (2) Remove the tailboom control rod and determine the number of bolt threads protruding from each nutplate on the internal surface of the aft tailboom frame casting, P/N 369D23503, as shown in Figure 1 of this AD. At least one thread must protrude. If more than four threads protrude, add an additional washer, P/N AN960D416, under the bolt head. Torque the bolt to 100-110 in-lbs, and reapply a slippage mark. See Figure 1:

(b) Between 2 and 10 hours TIS after accomplishing the requirements of paragraph (a) of this AD, inspect the torque on each bolt by applying 100 in-lbs. If any bolt movement occurs, retorquing the bolt to 100-110 in-lbs and reapply a slippage mark. Reinspect the torque between 2 and 10 hours TIS thereafter until no bolt movement occurs.
