# EMERGENCY AIRWORTHINESS DIRECTIVE

**DATE: August 19, 2002**  
**AD #: 2002-17-51**

**2002-17-51 AGUSTA S.p.A.: Docket No. 2002-SW-42-AD. Supersedes Emergency AD 2002-14-51, Docket No. 2002-SW-35-AD.**

Applicability: Model A109E helicopters, with tail rotor blade, part number 109-8132-01-111, installed, certificated in any category.

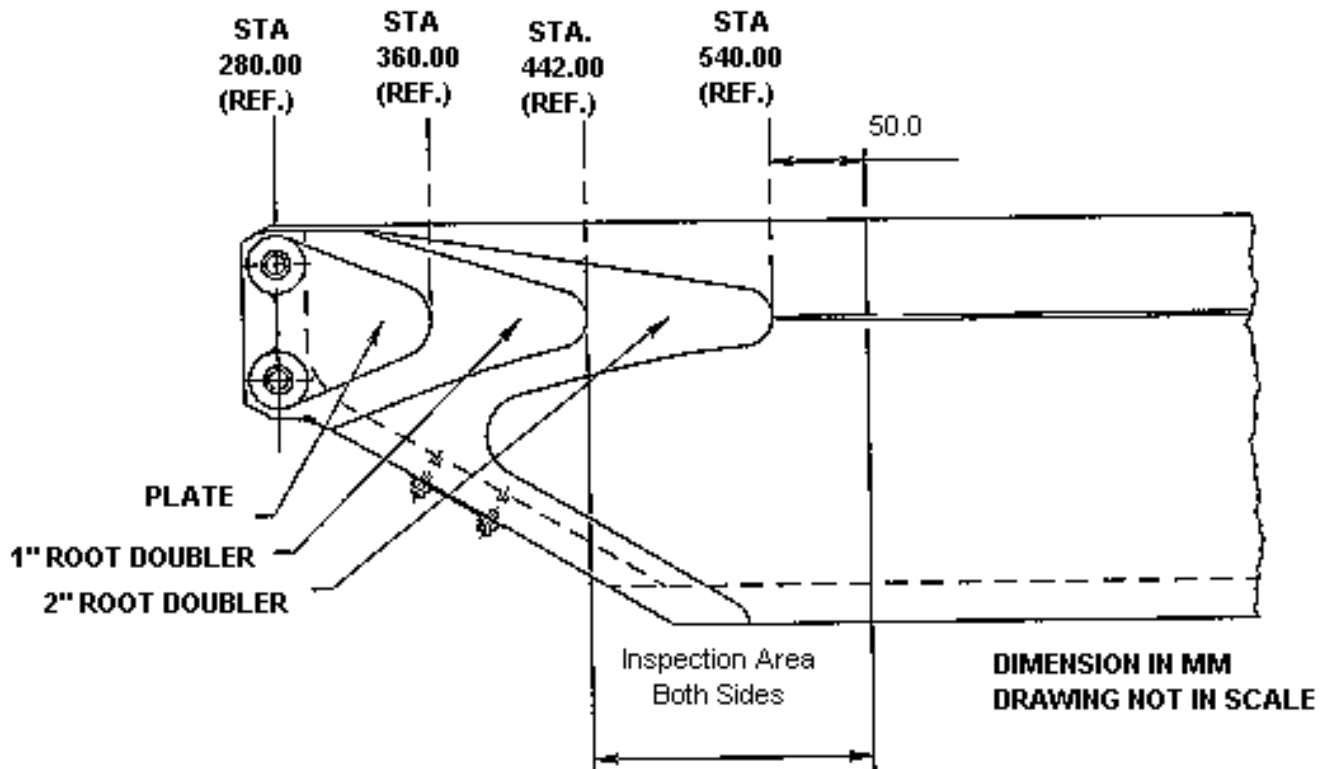
FIGURE 1

This superseding Emergency Airworthiness Directive (AD) is prompted by a failure of a tail rotor blade that resulted in a forced auto-rotative landing. The failure of the tail rotor blade was due to a fatigue crack. This condition, if not detected, could result in the failure of a tail rotor blade and subsequent loss of control of the helicopter.

(b) Before each start of the helicopter engines, visually check both sides of each tail rotor blade for a crack in the area depicted in Figure 1 of this AD. An owner/operator (pilot) holding at least a private pilot certificate may perform this visual check and must enter compliance with this paragraph into the aircraft maintenance records in accordance with 14 CFR 43.11 and 91.417(a)(2)(v). See Figure 1:

Part Number 109-8132-01-111 Tail Rotor Blade

Note 2: Paint irregularities on the tail rotor blade may be due to a crack.

(d) Replace any cracked tail rotor blade with an airworthy blade before further flight.
