**[Docket No. 2001-SW-58-AD; Amendment 39-12726; AD 2001-25-52]**

**Airworthiness Directives; Schweizer Aircraft Corporation Model 269A, 269A-1, 269B, 269C, and TH-55A Helicopters**

**2001-25-52 Schweizer Aircraft Corporation:** Amendment 39-12726. Docket No. 2001-SW-58-AD. Supersedes AD 76-18-01, Amendment No. 39-2707, Docket No. 72-WE-23-AD.

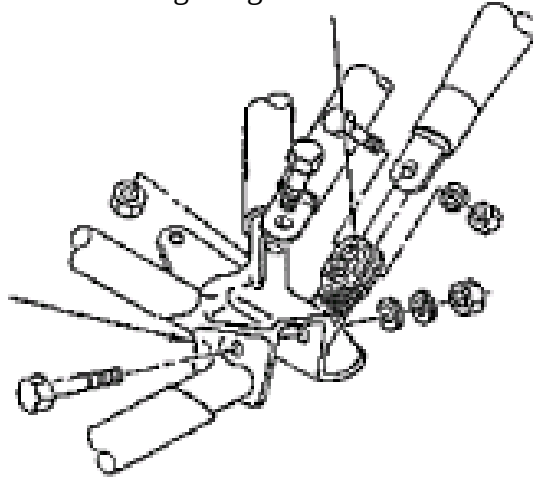
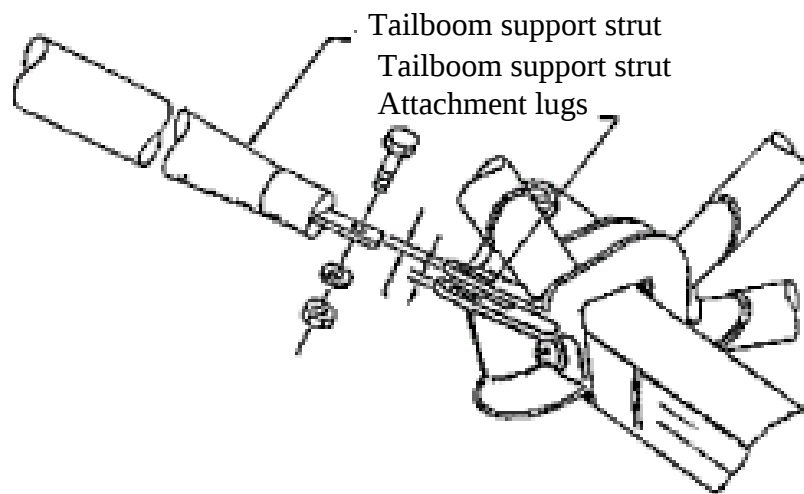
**Figure 1**

To prevent failure of a strut clevis lug (lug) on a center frame aft cluster fitting (cluster fitting), rotation of a tailboom into the main rotor blades, and subsequent loss of control of the helicopter, accomplish the following:

Inspect both attachment  
lugs (top and bottom sides).  
Also entire cluster fitting  
including flange area.

269A2234  
Aft cluster fitting  
Left side shown  
(269A2235 Right side)

**Right Side Cluster Fitting Shown**

(2) Dye-penetrant inspect the lugs on each aft cluster fitting. See Figure 1.

(3) If a crack is found, before further flight, replace the cracked cluster fitting with an airworthy cluster fitting. Cluster fittings, P/N 269A2234 and 269A2235, are not eligible to replace a cracked cluster fitting.
