# EMERGENCY AIRWORTHINESS DIRECTIVE

**DATE: July 9, 2002**  
**AD #: 2002-14-51**

**2002-14-51 AGUSTA S.p.A.: Docket No. 2002-SW-35-AD.**

Applicability: Model A109E and A119 helicopters, with tail rotor blade, part number (P/N) 109-8132-01-111, installed, certificated in any category.

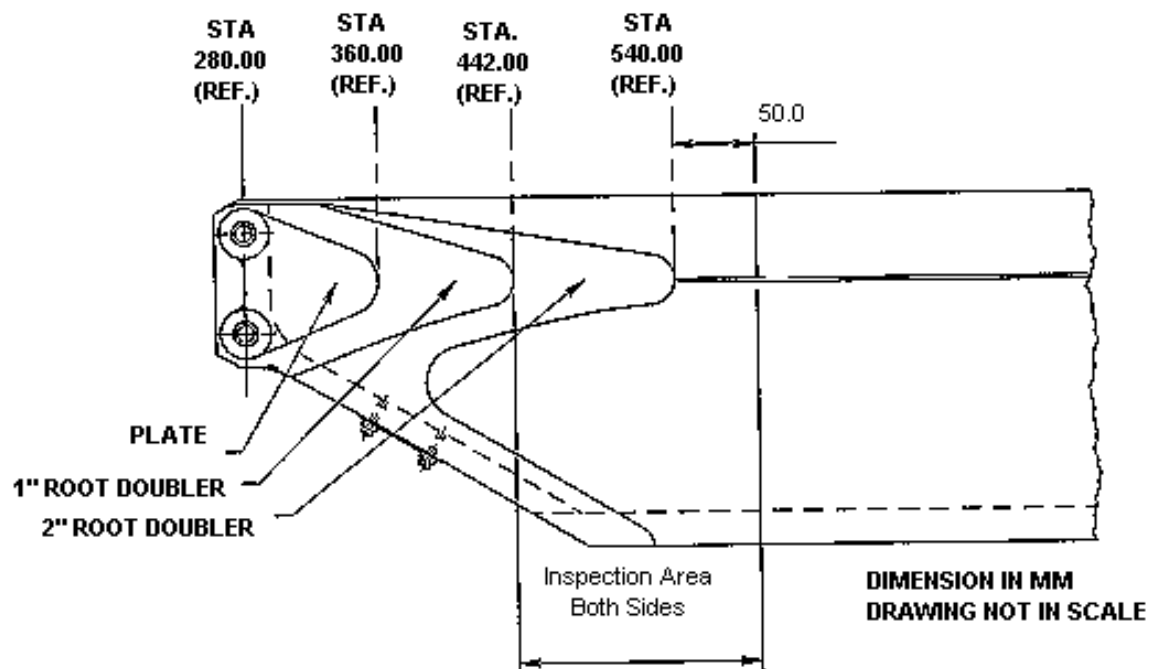
FIGURE 1

This Emergency Airworthiness Directive (AD) is prompted by the failure of a tail rotor blade resulting in a forced auto-rotative landing. The failure of the tail rotor blade was due to a fatigue crack. This condition, if not detected, could result in failure of the tail rotor blade and subsequent loss of control of the helicopter.

(a) Before each flight, visually check each tail rotor blade on both sides for a crack as shown in Figure 1 of this AD. Paint irregularities may be due to a crack. If irregularities are found, consult with a mechanic. The pilot must enter compliance with this paragraph in accordance with 14 CFR 43.11 and 91.417(a)(2)(v).

Part Number 109-8132-01-111 Tail Rotor Blade

(b) Within 5 hours time-in-service (TIS) and thereafter at intervals not to exceed 5 hours TIS, using a 5X or higher magnifying glass, visually inspect each tail rotor blade for a crack in accordance with the Compliance Instructions, Part II, paragraphs 1 through 5, of Agusta Bollettino Tecnico (BT) Nos. 109EP-30 for Model A109E or 119-6 for Model 119-6, both dated June 21, 2002.

(c) If you are unable to determine by the visual inspection whether there is a crack, dye penetrant inspect the tail rotor blade for a crack in accordance with the Compliance Instructions, Part II, paragraphs 6 through 7, of Agusta BT Nos. 109EP-30 for Model A109E or 119-6 for Model 119-6, both dated June 21, 2002.

(d) If a crack is found, before further flight, replace any cracked tail rotor blade with an airworthy tail rotor blade.
